RE: BIENNIAL INSPECTION OF MUNICIPALLY OWNED BRIDGES
TOWN OF SANDOWN

Sandown 093/109

PHILLIPS ROAD

EXETER RIVER

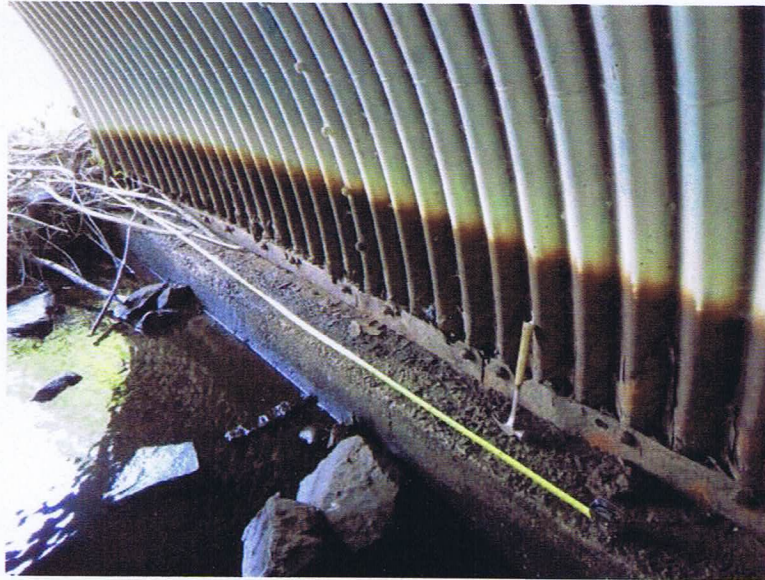
C537 11

MP IS TORN AND HOLED
WITH 100% SECTION LOSS
AT NORTHWEST FOR 14'.
(RL)

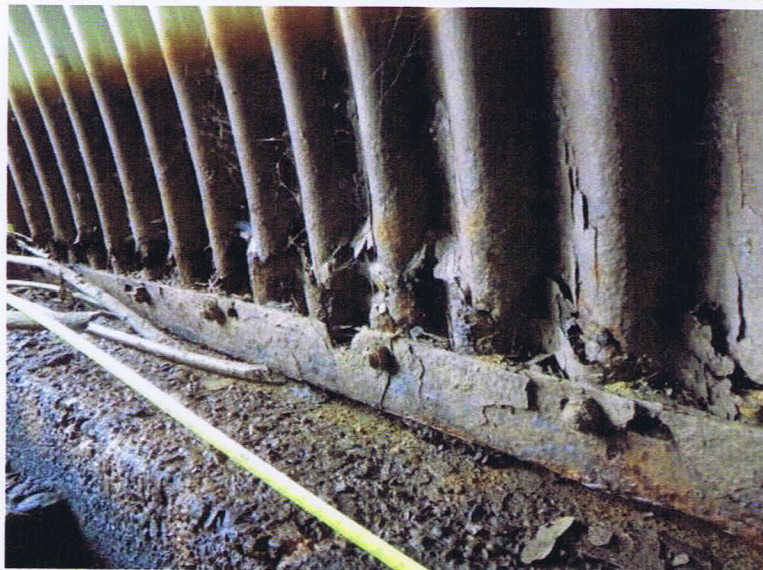
C537 12

CONCRETE IS SPALLED
BELOW NORMAL WATER
LINE AT SOUTH. (RL)

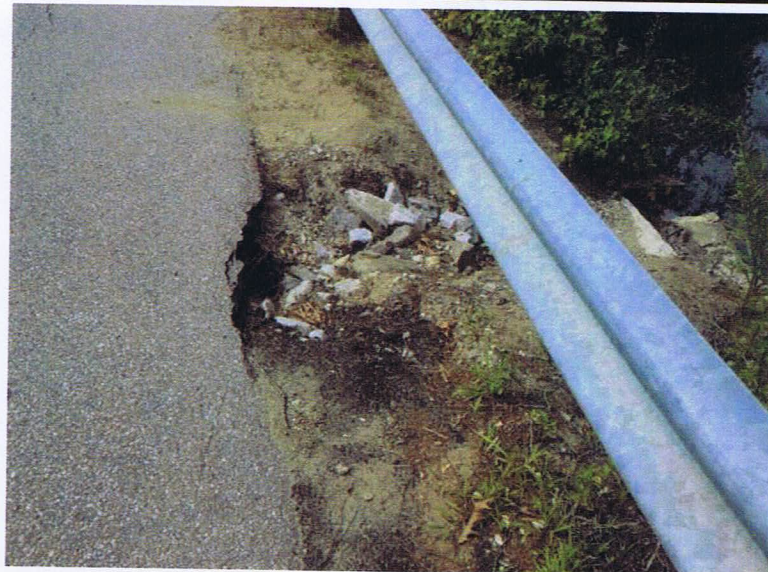
C537 14

WASHED AREA AT WEST
OVER MP IS ENCROACHING
ON ROADWAY. (RL)
