DRY WEATHER OUTFALL INSPECTION REPORT

To: Ms. Lynne Blaisdell, Town Administrator
From: Nick Cristofori, P.E., Comprehensive Environmental Inc.
Date: November 25, 2020
Town: Sandown, NH
Subject: Dry Weather Outfall Inspection and Screening

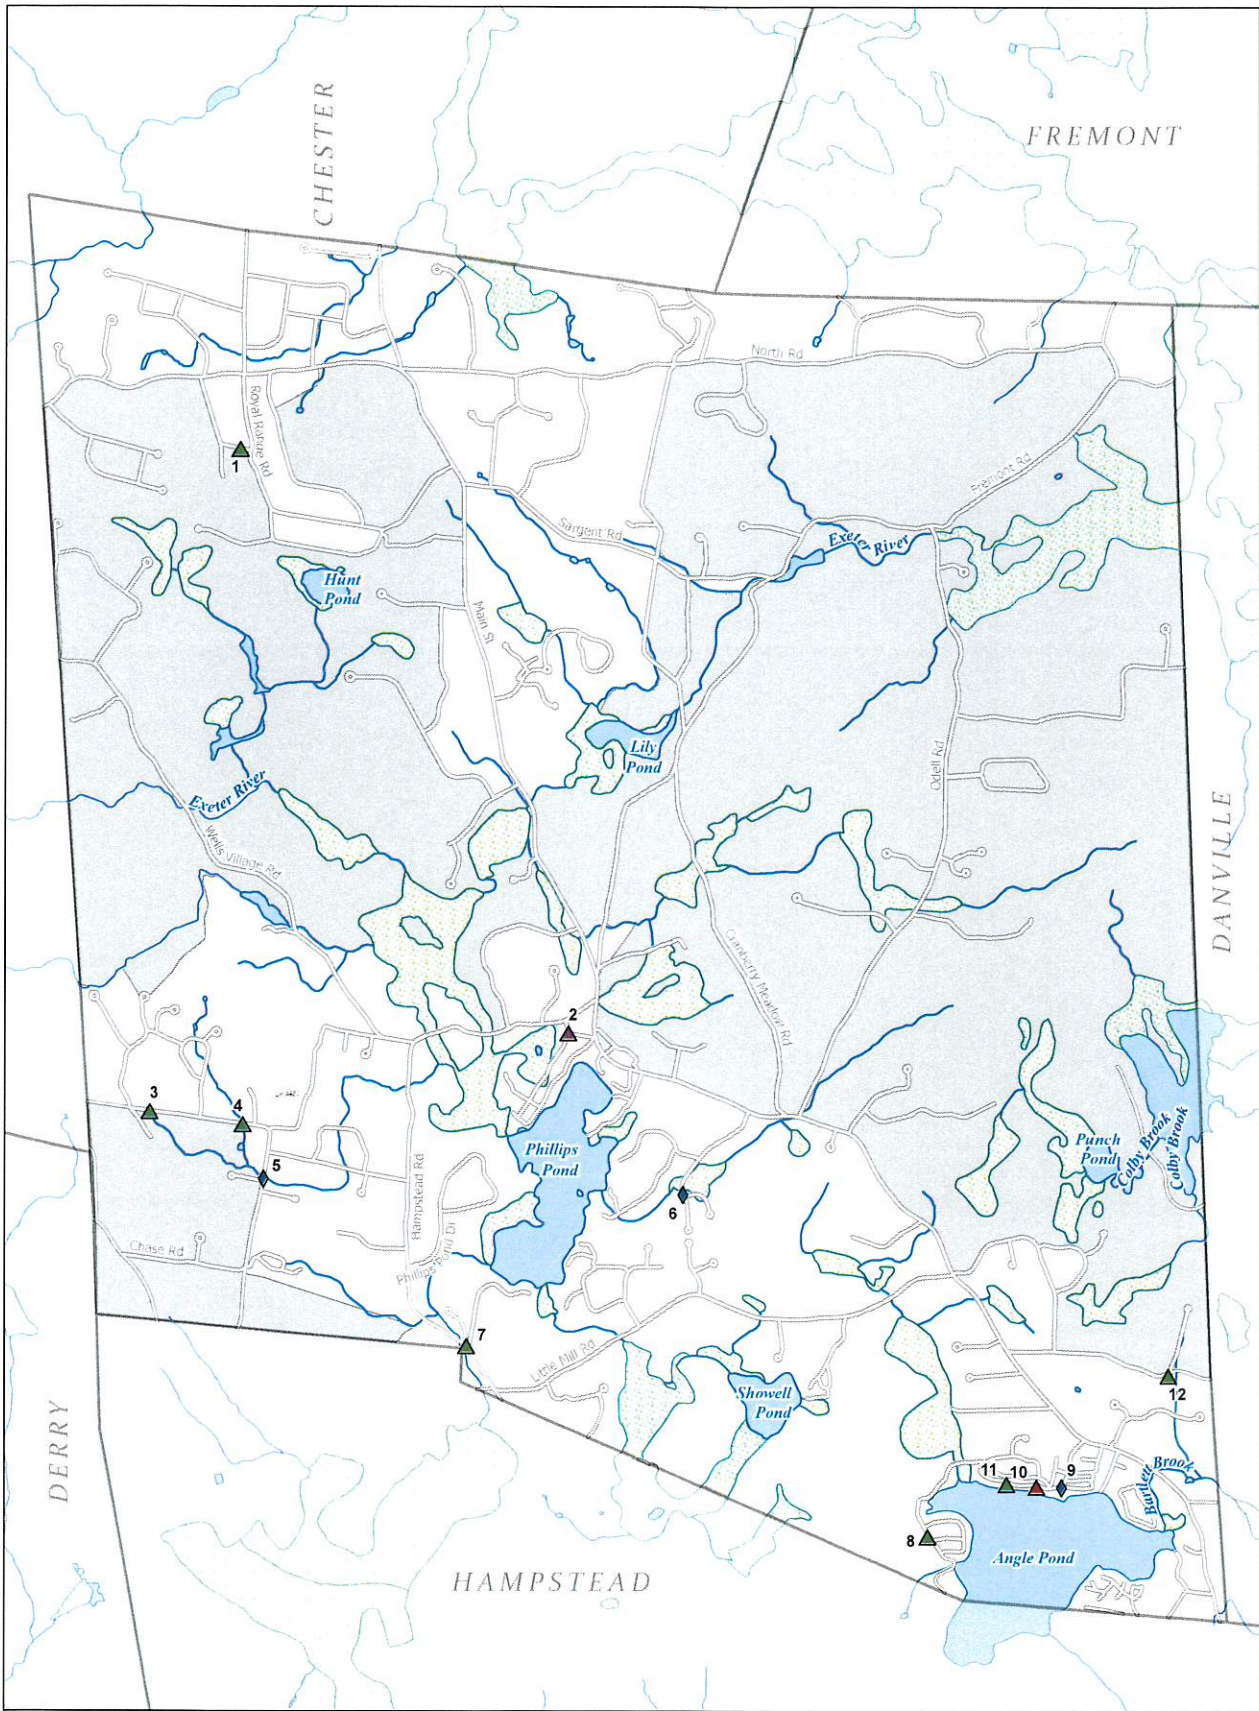
- Dry Weather Outfall Sampling Results map
- Table of Results

Legend

- Outfall Inspection Result:
- ▲ Not Flowing
 - ▲ Not Found
 - ▲ Could Not Access
 - ◆ Culvert
 - Roads
 - Lake, Pond, Reservoir
 - Swamp, Marsh
 - ~ Stream, Brook
 - Non-Urban Area
