Long-Term Variable Milfoil & Fanwort Management Plan

Phillips Pond
Sandown, New Hampshire

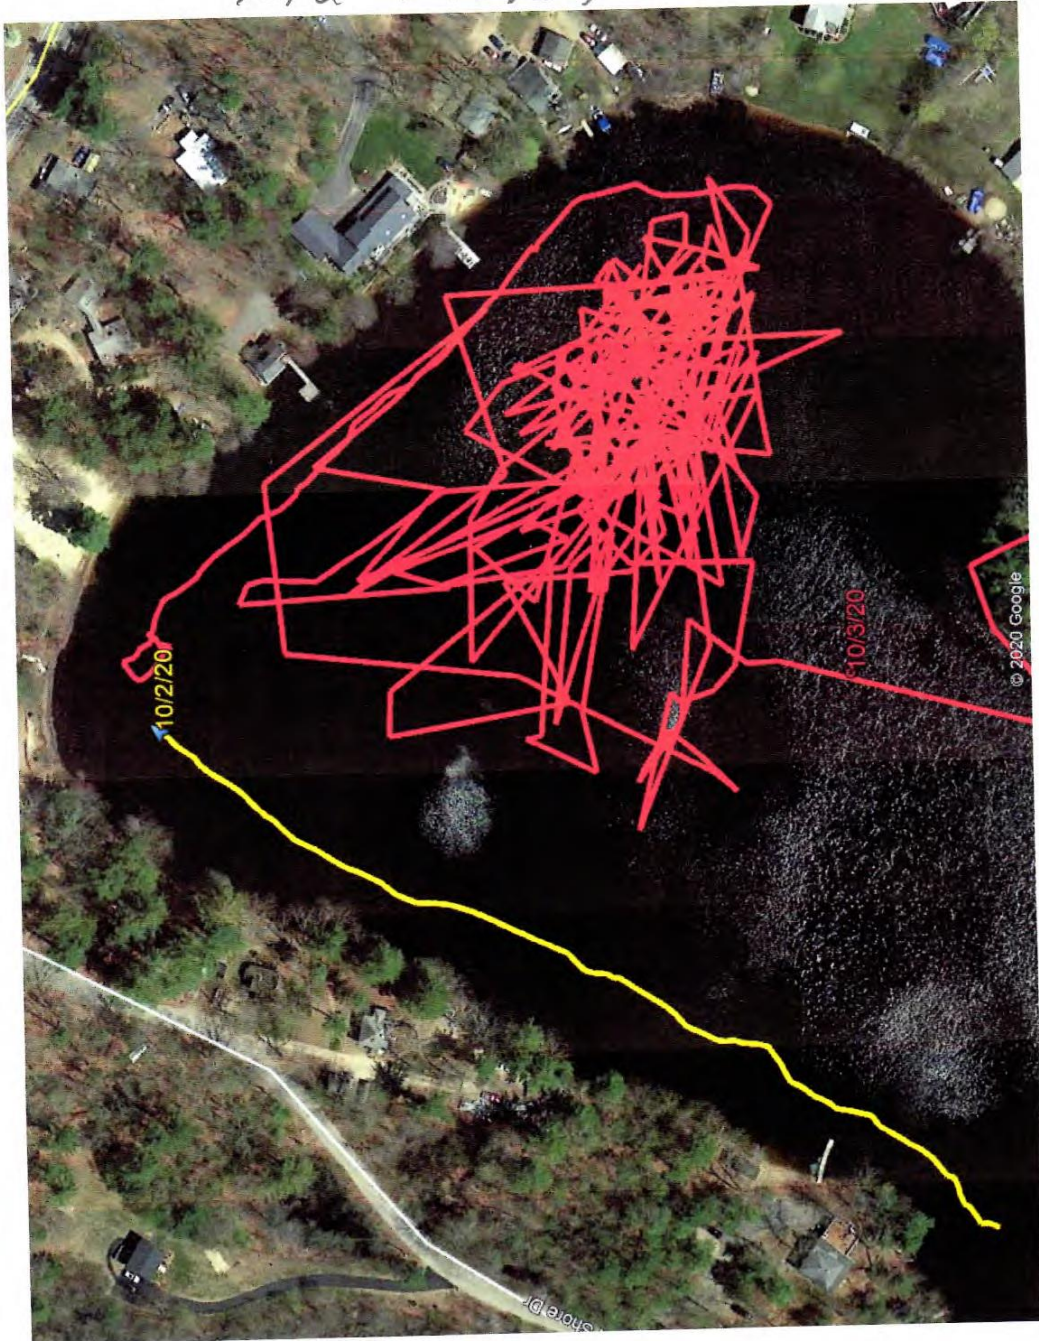
10/2 + 10/3 / 20

2020 Diving

S1 & S2 NW end	10/02/2020	DIVER/DASH	80 GALLONS	AB AQUATICS
